**FEDERAL ENERGY REGULATORY COMMISSION
ENVIRONMENTAL REPORT**

**COVE POINT EXPANSION PROJECT
DOMINION TRANSMISSION, INC.
DOCKET NO. CP05-131-000**

**COVE POINT EXPANSION PROJECT
DOMINION TRANSMISSION, INC. PIPELINES
DOCKET NO. CP05-131-000
JUNIATA, MIFFLIN, HUNTINGDON, CENTRE, CLINTON,
GREENE AND POTTER COUNTIES, PENNSYLVANIA
AND WETZEL COUNTY, WEST VIRGINIA**

**Phase I Bog Turtle Habitat Evaluation
at the PL-1 Replacement and PL-1 Retest Sites at the
Dominion Transmission Inc. Cove Point Project in
Hamilton and Fannet Townships,
Franklin County, Pennsylvania**

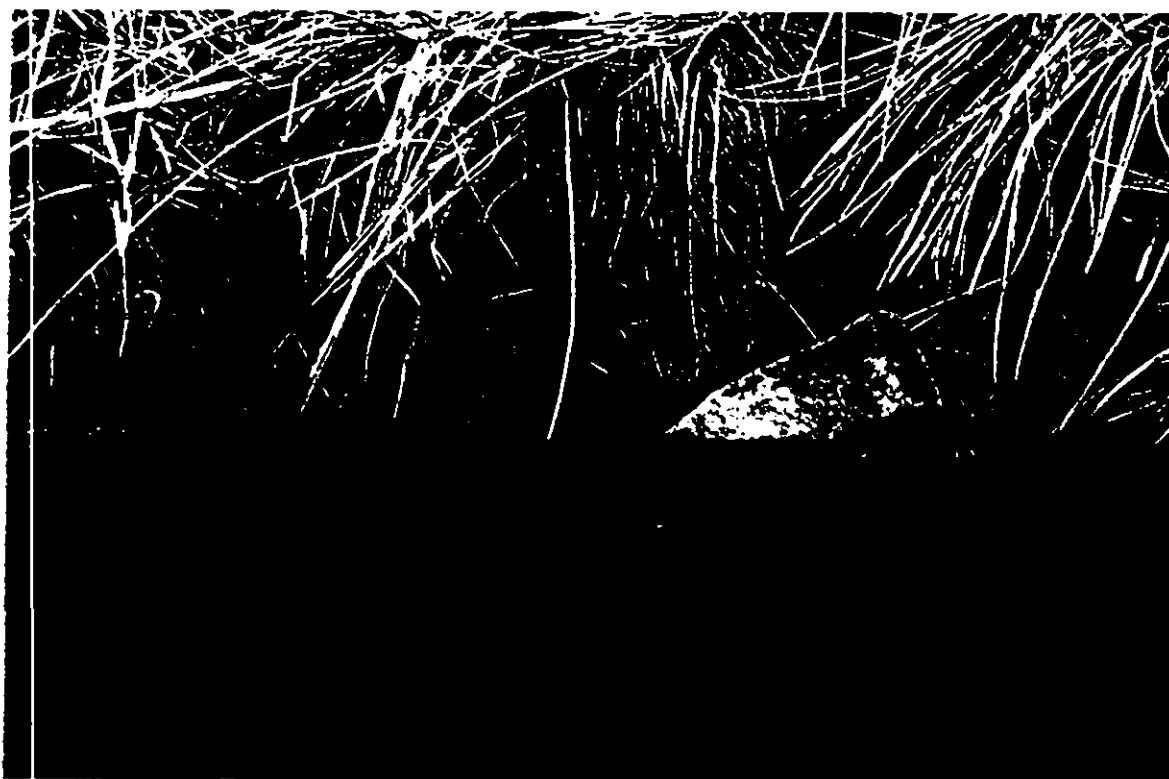
Photograph 10. Middle Branch of the Genesee River, bank conditions.

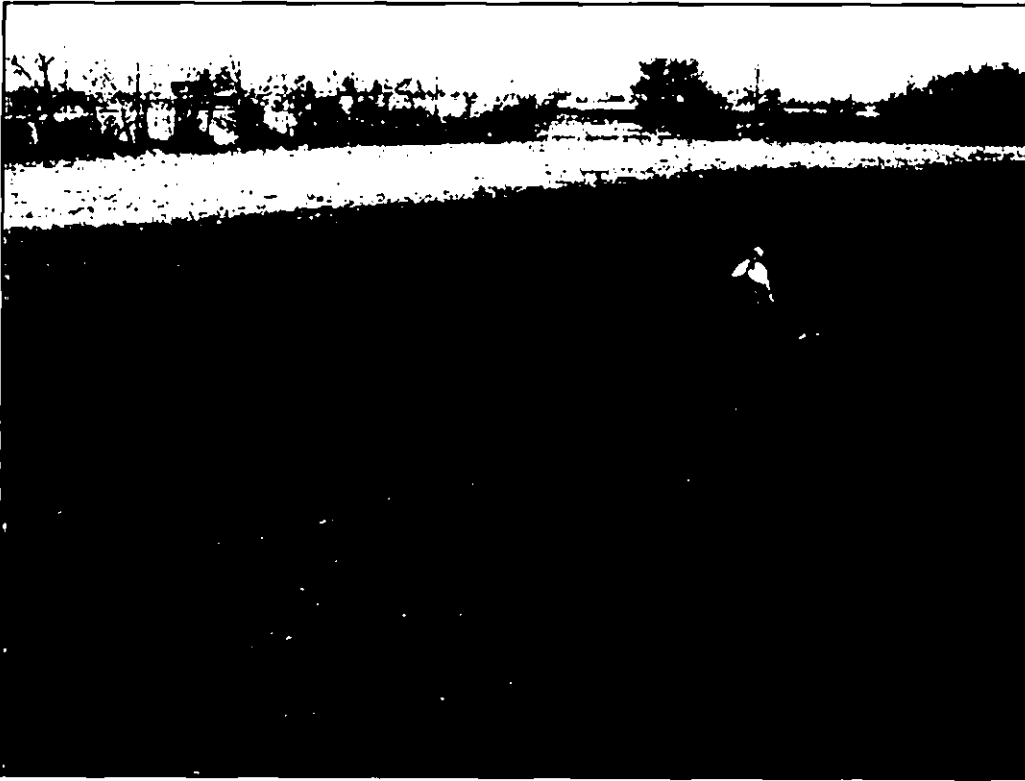
Figure 5. A view of the drainage ditch associated with Back Creek from the adjacent hill side. The wetland area is located in the top right corner and Back Creek is indicated by the tree line in the background of this photograph.

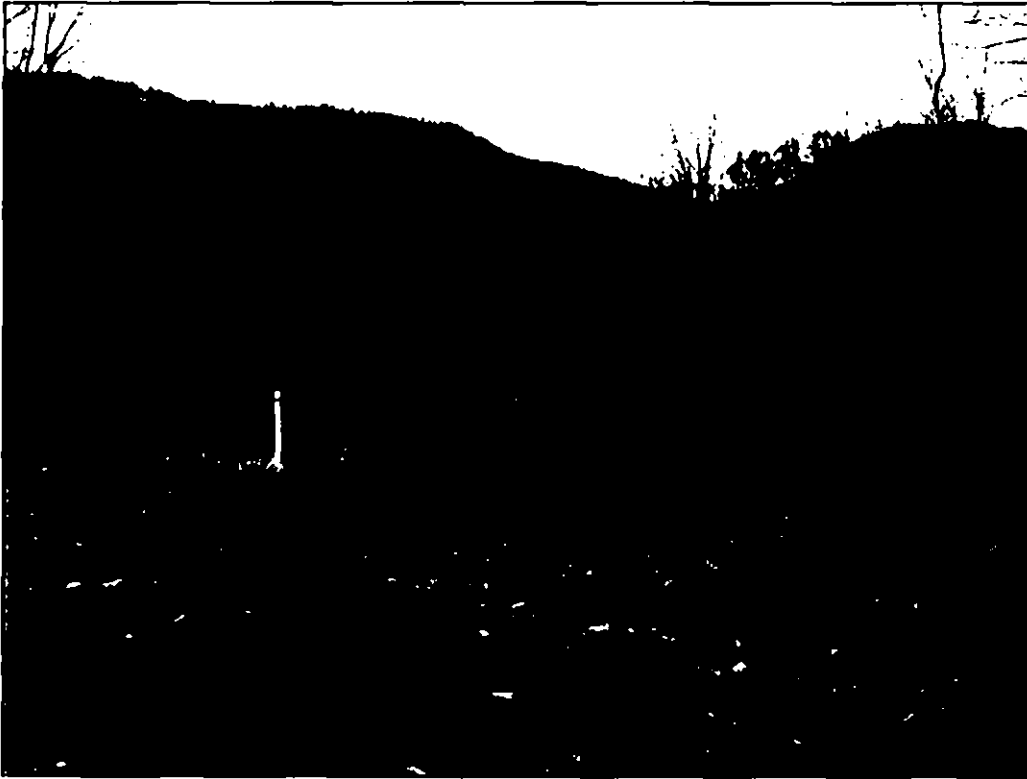
Figure 7. A northerly view from within the PL-1 Retest section. The wetland area is within the center of this portion of the ROW.

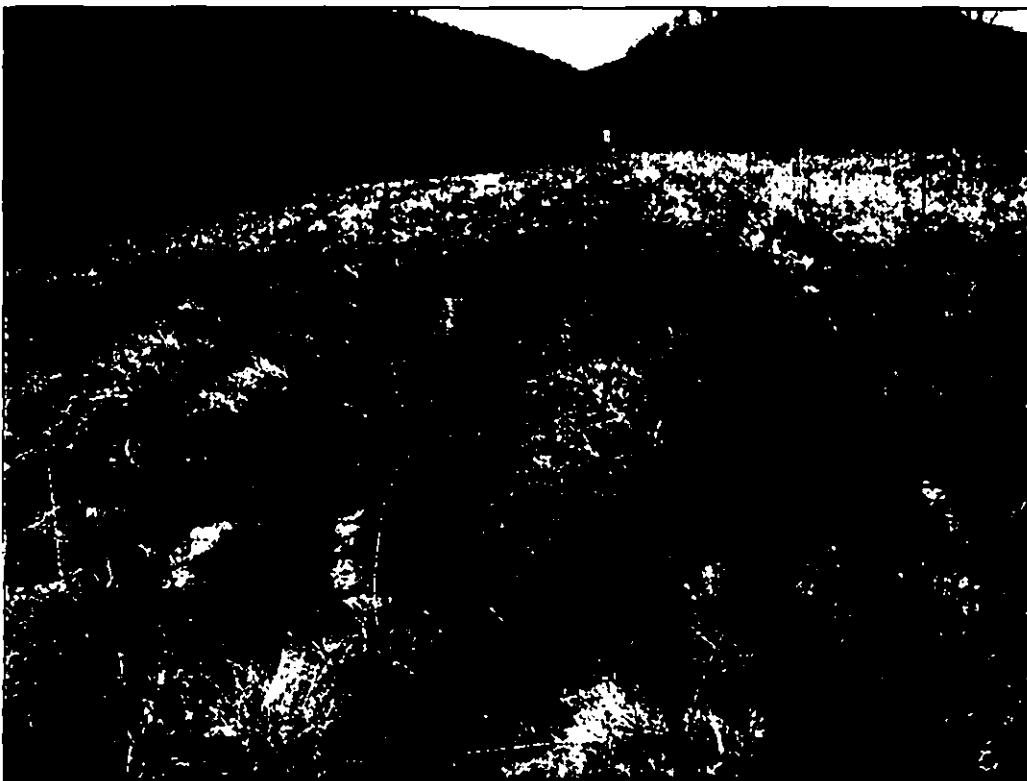
Figure 8. This wetland area contains only shallow muck and water in the old tire ruts shown in this northerly view from within the ROW.
